Accessible Pedestrian Signals: Installation Details

Janet M. Barlow, COMS, Accessible Design
for the Blind

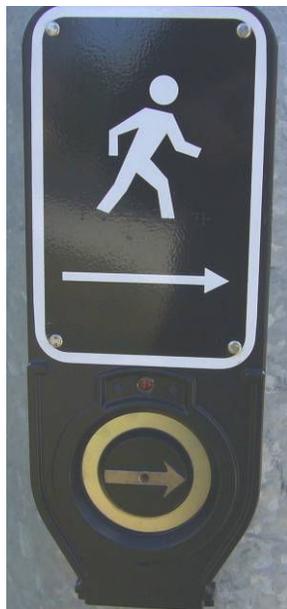
Figure 1 Pushbutton-integrated APS (Polara)

Figures 1 and 2 show several of the pushbutton-integrated APS devices that are available in the US. All include a pushbutton that is at least 50 mm (2 inches) in diameter, audible and vibrotactile WALK indications, a pushbutton locator tone, a tactile arrow, and automatic volume adjustment. Configuration, functioning, and adjustment methods vary somewhat by manufacturer.⁵

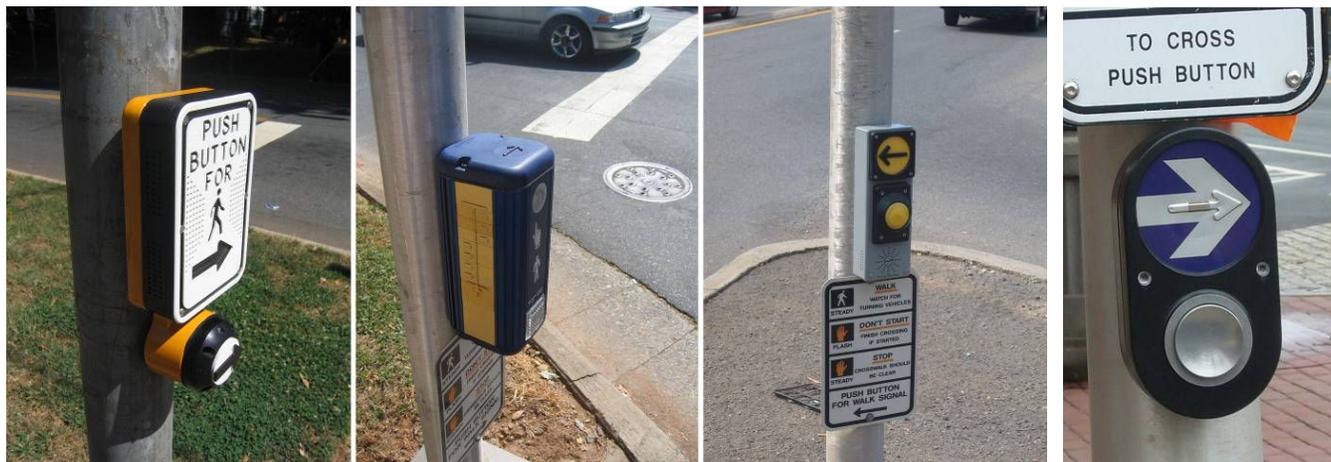
Figure 2 Examples of pushbutton-integrated APS from various manufacturers (left to right: Campbell, Prisma, Novax, Panich; Polara shown in figure 1)

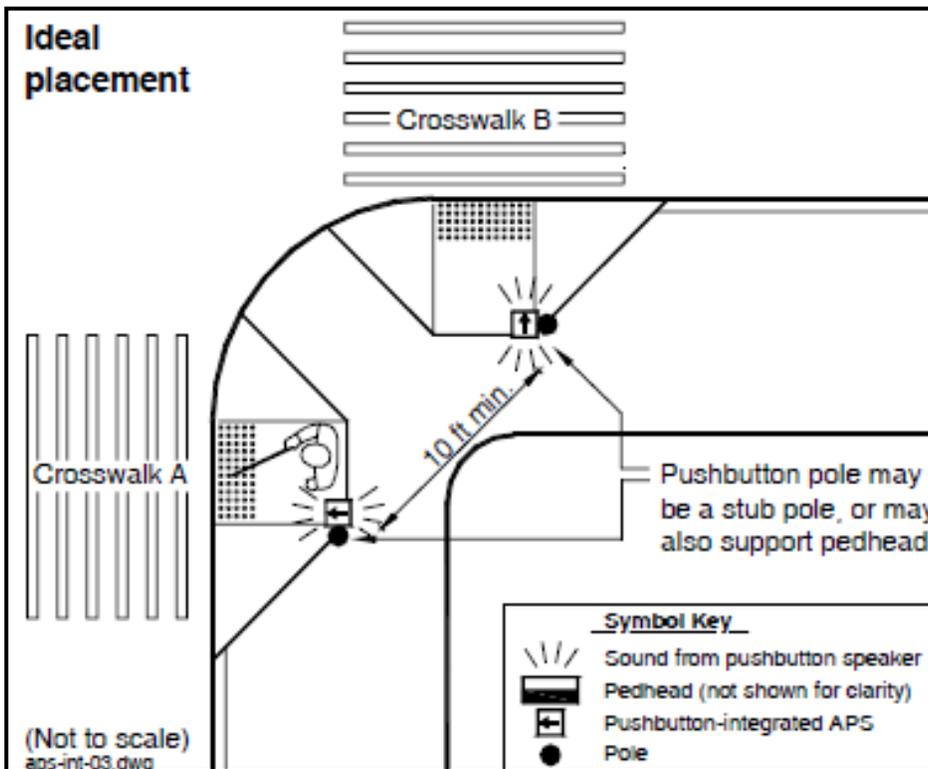
Figure 3 Optimal location of pushbutton-integrated APS – two pushbuttons on one corner, mounted on two separated poles – rapid tick WALK indication

more than 3m (10 feet) maximum from the curb line (and closer, if possible), and between the curb ramp landing and the outside crosswalk line, or no more than 1.5m (5 feet) maximum from the outside crosswalk line.^{6 7} See Figures 3⁸ and 4 for illustrations of pushbutton locations.

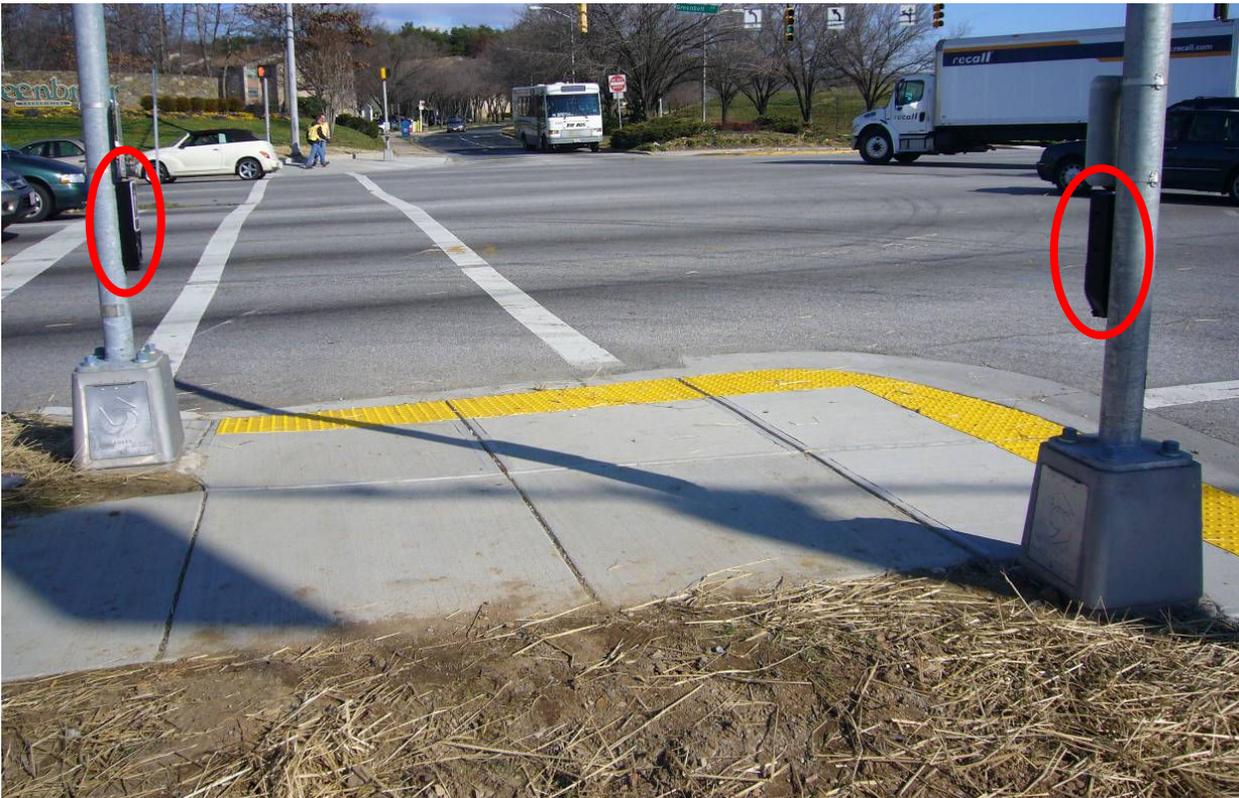
Figure 4 Installation of APS on two separated poles, aligned with crosswalk lines (APS devices circled in red)

Remedy: If possible, move the APS to separated poles, each close to the crosswalk it controls and indicates (see Figures 3 & 4).

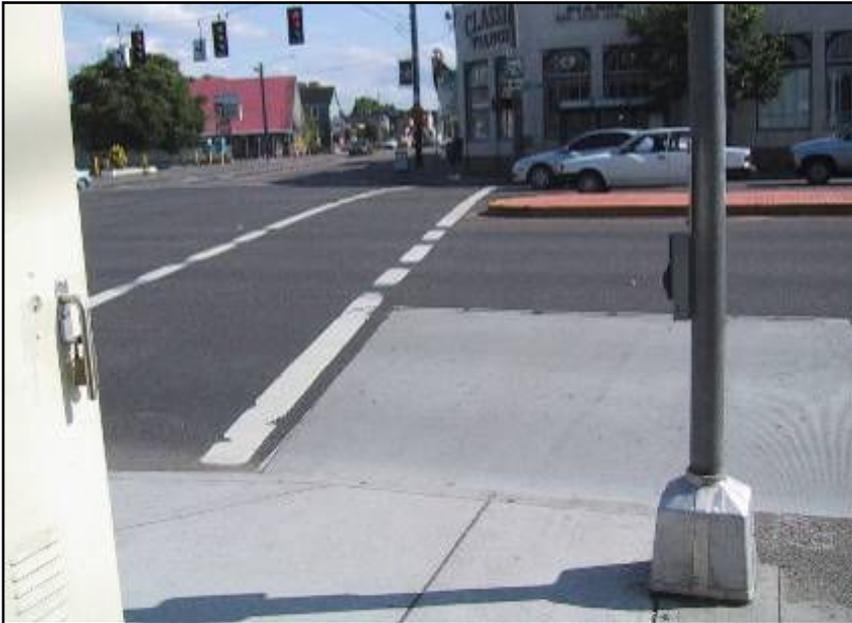
Figure 5 APS is located about 8 feet from the crosswalk and curb ramp landing

In the situation pictured in Figure 5, pedestrians who begin their crossing beside the pushbutton would be outside the crosswalk lines and may not be anticipated by turning drivers. If the pedestrian who is blind also encounters the median island and stops, there is no APS or pushbutton on the median to call a WALK to complete the second half of the crossing. Since the APS is not close to the crosswalk and curb ramp, the volume of the audible walk indication and pushbutton locator tone must also be louder in order to be heard from the crossing location.

Remedy: One solution is to move the pole closer to the crosswalk lines, so the device is in reach of the landing of the curb ramp and adjacent to the crosswalk. This will assist pedestrians who are blind in finding the APS pushbutton and in beginning crossing from within the crosswalk area.

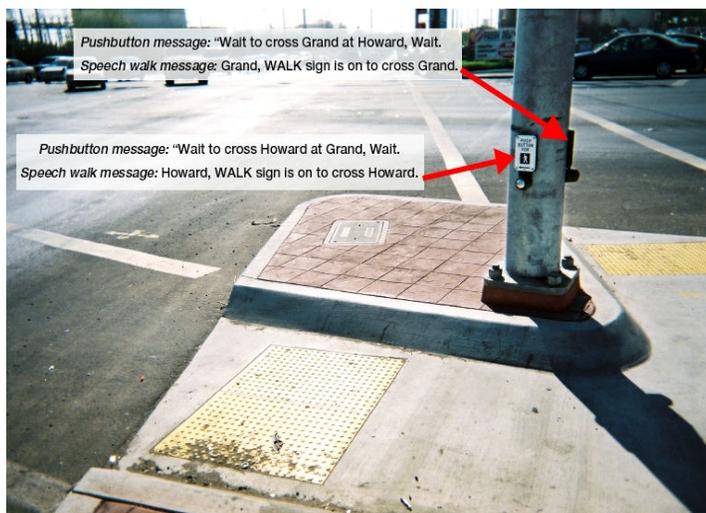
Figure 6 Example of pushbutton information messages and speech walk messages, if two APS must be mounted on the same pole Alterations only

In numerous installations evaluated in the field, where two APS were mounted on the same pole, installers failed to customize the messages and used the manufacturer's default message, 'WALK sign is on'. With two APS located closer than five feet to each other, it is impossible to distinguish which one is sounding based on the location and direction of the sound. Pedestrians standing at one crosswalk could mistake the message of the other crosswalk for their indication to begin crossing.

In Figure 6, it appears that the required separation of APS mounting poles (10 feet minimum) could have been achieved here by locating stub poles to the left side of the left ramp and the right side of the top crossing. That would have provided much less ambiguous information for pedestrians using these crossings. While a common pole is permitted where existing constraints preclude separated poles, it should not be the selected solution where separated poles are possible.

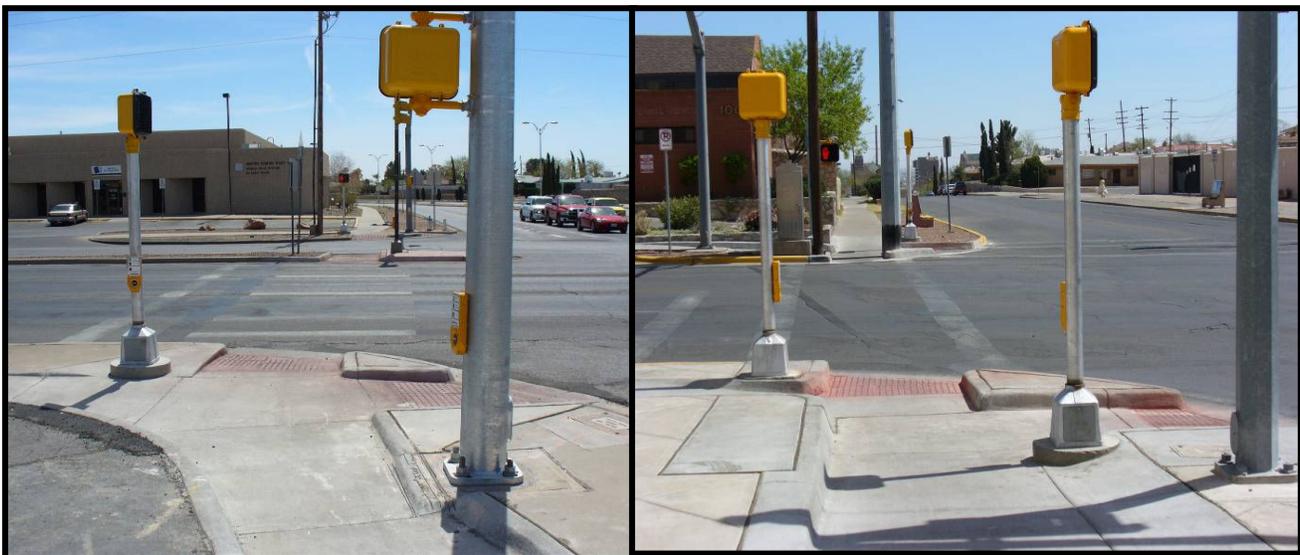
In Figure 7, APS have been installed on the wrong poles. The APS on the pole in the left of the photo has an arrow pointing toward the street on the right in the photo. Since the APS is closer to the departure curb and curb ramp for crossing straight ahead (in line with the photographer's direction of travel), a pedestrian hearing the sound from that APS would expect that the APS governs that crossing, and may not even be able to hear the further distant APS that is actually for the crossing he/she intends (in the foreground of Figure 7).

Figure 8 Installation where APS are installed in wrong locations; both are too far from street they control and will be heard as closer to the other street

Figure 8 Installation where APS are installed in correct locations in relation to crosswalks

Remedy: Each APS should have been installed on the pole closest to the crosswalk it controls, as shown in Figure 8. For example, the APS for the crossing on the right in Figure 7 should be installed on the pole near the right side of the photo, and on the side of the pole toward the curb ramp, but still reachable from the level sidewalk. This will allow pedestrians to push the button and then hear the APS at the crosswalk departure point. The APS on the

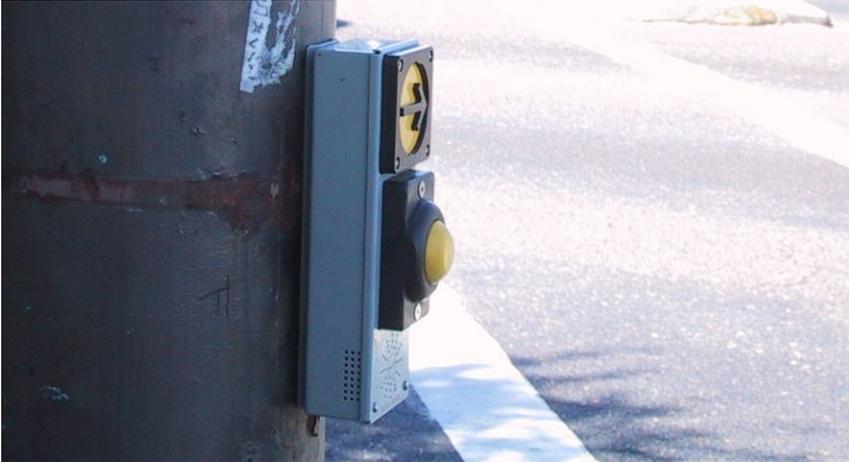
Misleading wayfinding information will be conveyed if the tactile arrow is oriented toward the center of the intersection, rather than parallel to the crosswalk. In the photo below (Figure 9), the arrow is out of alignment with the crosswalk direction. Even small misalignments can inadvertently direct a blind pedestrian outside the crosswalk area or into the parallel traffic.

Figure 9 Tactile arrow not aligned with crosswalk direction

Remedy: The APS needs to be removed and reinstalled. The arrow must be aligned with the direction of travel on the crosswalk.

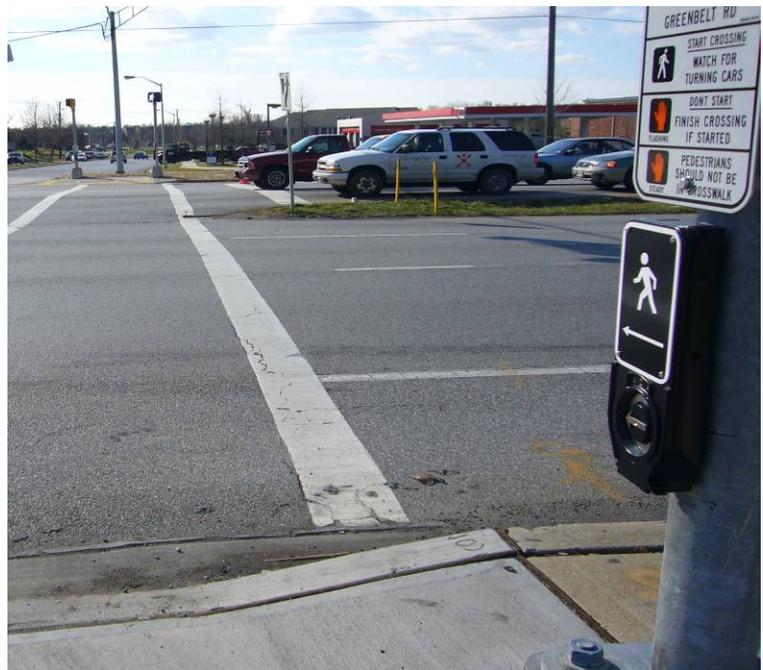
Figure 10 Location where tactile arrow is aligned with direction of travel on the crosswalk

Since the tactile arrow is on the face of the device or on the pushbutton, the APS mounting affects arrow alignment. If the needed adjustment is minor, it may be possible to shim behind one side of the device to align the arrow with the crosswalk. In other cases, it may be necessary to drill new mounting holes and reposition the APS on the pole. The arrow should be aligned as shown in Figure 10.

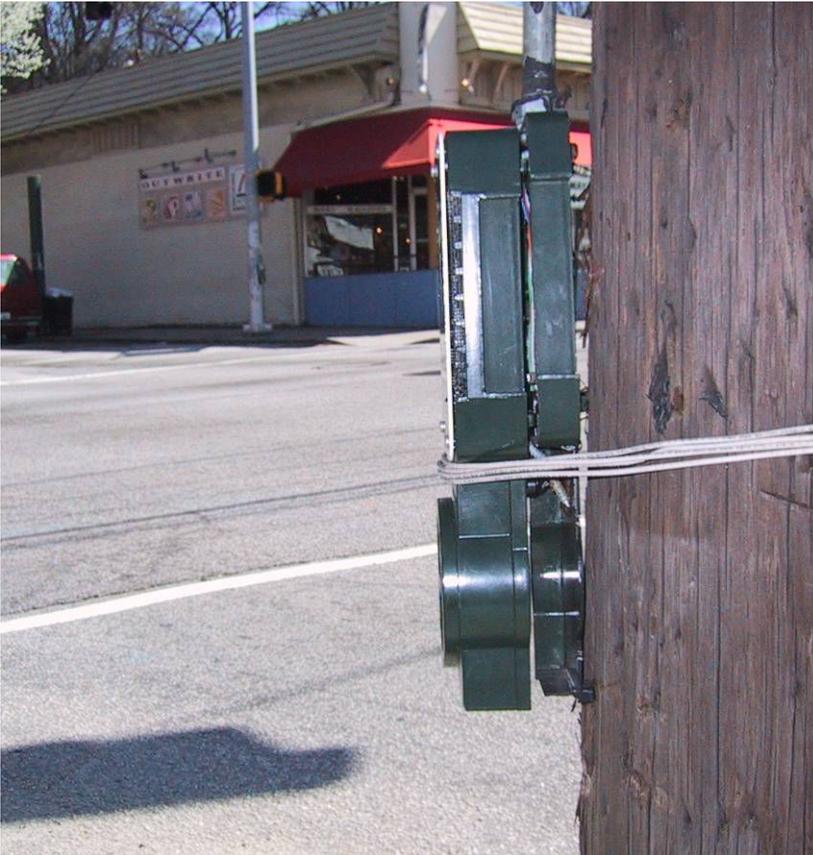
In another situation, shown in Figure 11, the APS was temporarily reinstalled, still functioning, but oriented incorrectly. It was several weeks before a crew reinstalled it properly. Meanwhile it provided inaccurate information. When the APS is not correctly installed, there is a risk that a person who is blind will cross a street with the wrong WALK indication or in the wrong direction.

Figure 11 APS that was damaged in a crash and temporarily reinstalled with wire

Remedy: All maintenance personnel need to know enough about APS installations to recognize an APS, and to either call someone to check details of reinstallation, or to correctly re-install the APS themselves. Training is needed to avoid dangerous errors in reinstallation or repair.

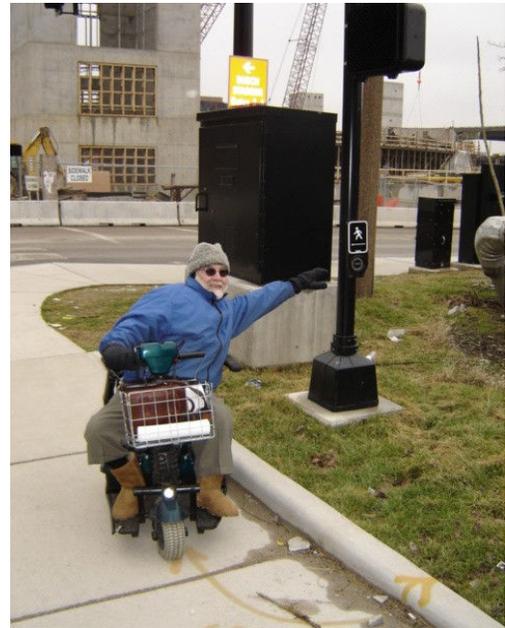
APS devices can be located in landscaped areas if the pushbutton is reachable from a level paved area. Figure 12 shows a location where new APS (and new sidewalks) were installed, but the APS are not usable. Besides the inaccessibility for wheelchair users, a person who is blind will have difficulty finding and getting to the pushbutton, even with the pushbutton locator tone sounding.

Figure 12 In this new construction, APS is located too far from the sidewalk to be reached by a user of a wheelchair or scooter

Remedy: Installation in landscaped areas must be carefully planned and monitored for accessibility. APS must be within the reach range (1.2 m/48 inches vertically, .25m/10 inches horizontally) for an individual who uses a wheelchair.²⁵

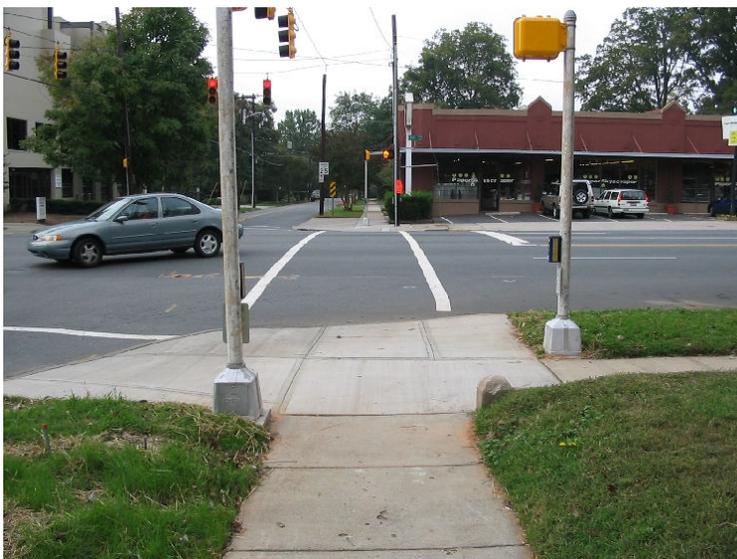
The APS shown in Figure 13 are appropriately located within the landscape strip, reachable from a paved level surface, and aligned with the crosswalk lines.

Figure 13: APS installed on poles in the landscape strip, and still within reach from a level paved sidewalk surface

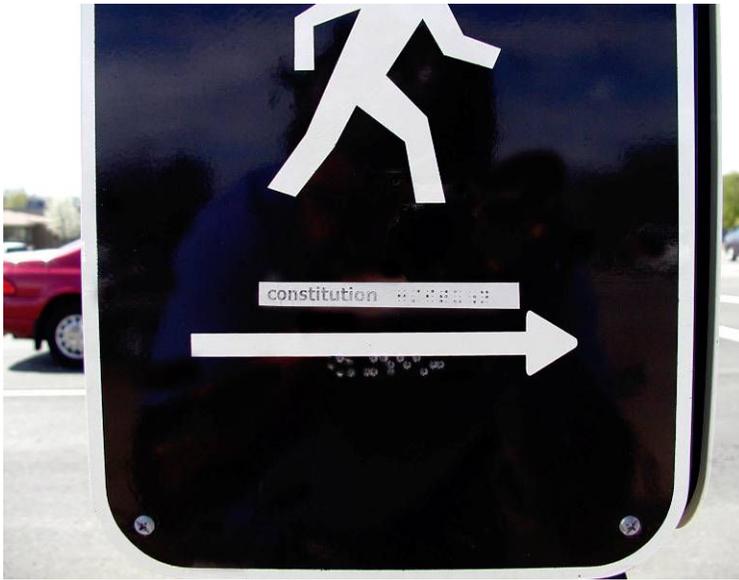
Figure 14 Braille sign installed backwards, with manufacturers' label showing. Label includes street name and print of how Braille should look. Braille beneath arrow is backwards version of the print version shown on label and is indented rather than raised.

Where the APS device includes the street name in Braille, care must be taken to install the signs in the correct location and orientation.

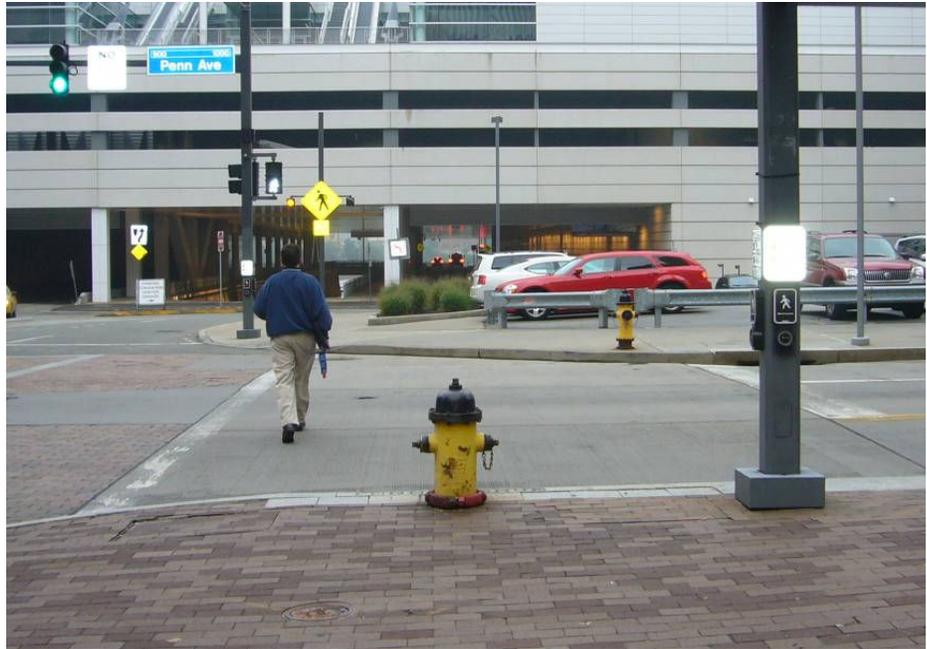
In addition, the street names are similar -- Penn and Tenth -- and it is quite difficult to discern which is being announced in the speech WALK message, particularly at the crosswalk for crossing Tenth (the street to the left in Figure 15), where the APS is too far from the street.

Figure 15 APS is located on mast arm pole more than 10 feet outside the crosswalk lines. In addition, a fire hydrant is between the crosswalk location (and the curb ramp) and the APS

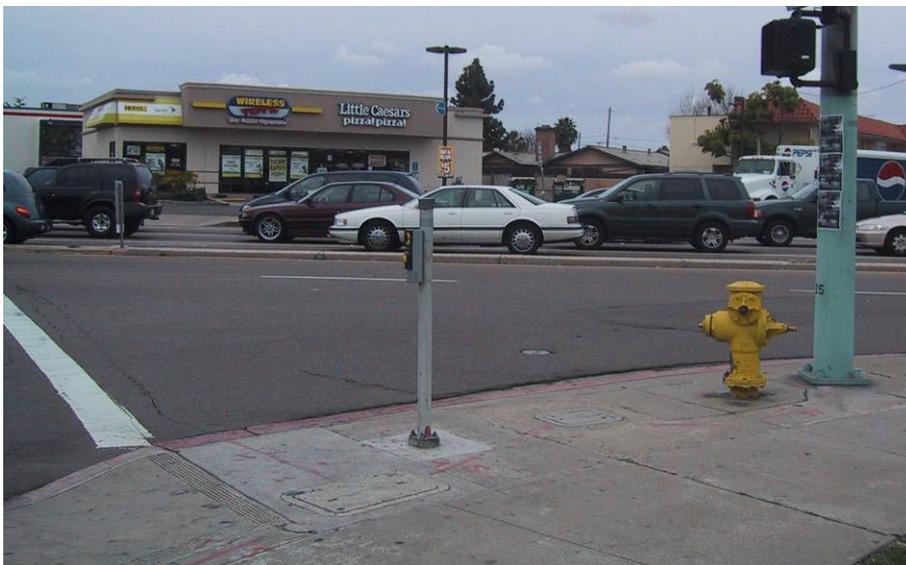
Figure 16 Stub pole was installed to locate APS near the crosswalk

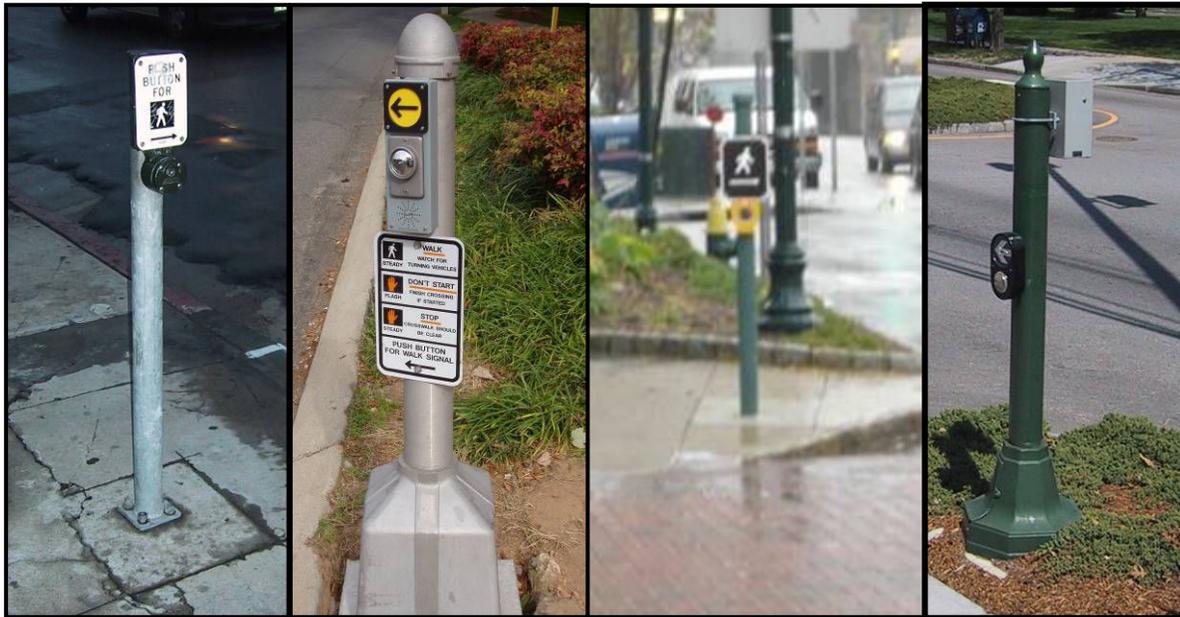
Figure 17 Examples of stub poles - different materials and installation

Some examples of stub pole installations across the US:

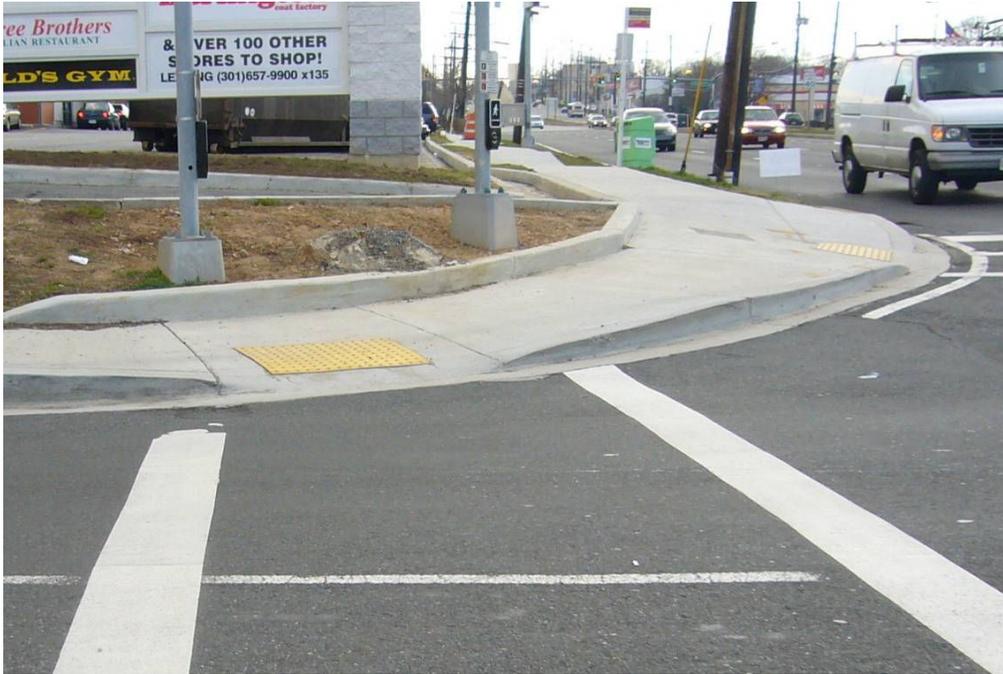
Figure 18 APS and curb ramps that were not installed as designed

points to the curb ramp, rather than being aligned with the direction of travel on the crosswalk. The poor location is more easily seen in Figure 19, taken from across the street. A red circle highlights where the pedestrian signal pole was supposed to be installed.

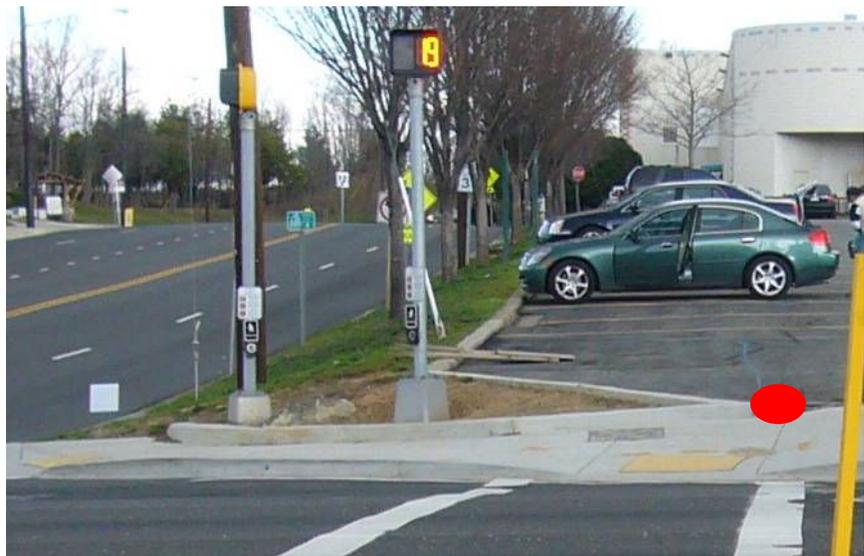
Figure 19 Another view of the same corner. Note shifting slopes and cross slopes on the ramps in addition to poor APS location

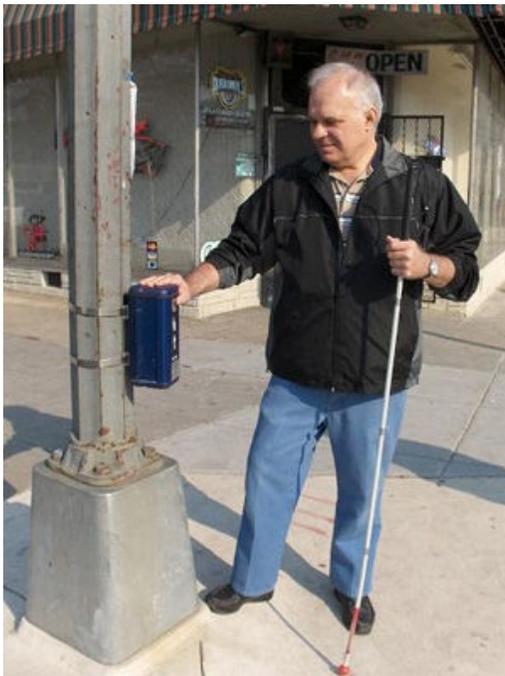
Figure 20 Deaf-blind user stands with his hand on the original APS to feel the vibration in order to know when to begin to cross

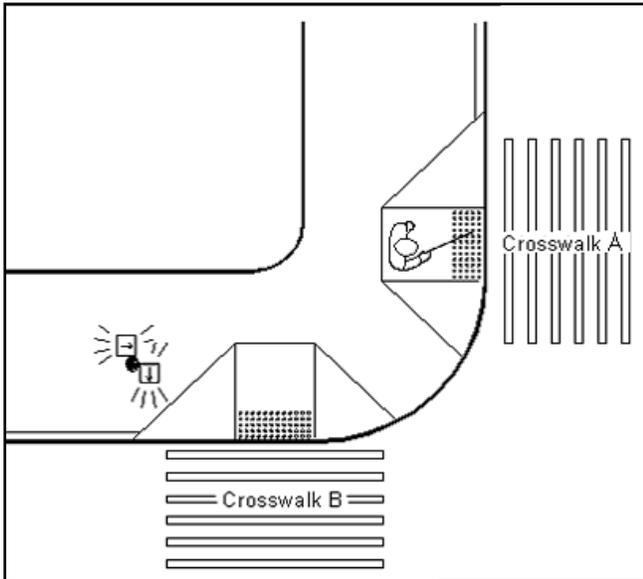
On the other corner, APS for the two different crossings were both installed on one pole, as shown in figure 21 and 22. The distance to the crossing (on crosswalk A) results in other problems. While there, it was noted that the Flashing Don't Walk (FDW) signal also was

Figure 22 When two APS are mounted on an existing signal pole, one is poorly located. The pushbutton for crosswalk B is near the crosswalk, but the pushbutton (and vibrotactile arrow) for crosswalk A is a long way from the crosswalk and can be difficult to travel.

This timing issue is complicated by the fact that the pedestrian pushbutton for THIS crossing is well over 10 feet from the street (see figures 21 and 22). It takes this deaf-blind pedestrian nine seconds to get to the crosswalk after detecting the vibrotactile signal. After he arrives at the departure curb, it takes him 18 more seconds to complete the crossing.

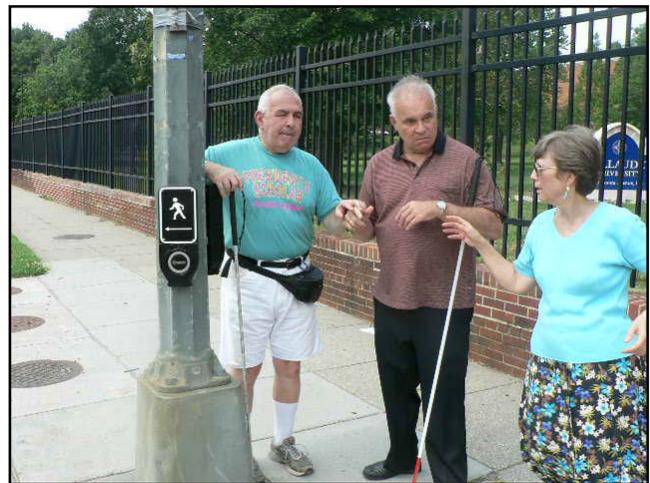
Figure 21 Orientation & mobility specialist approaches two deaf-blind individuals to explain the APS (two APS on same pole). One crossing is a few feet to the left of the photo; the other is about 20 feet away, straight ahead of individual with arm on top of APS
